Manhole Inspection Summary

Manhole # S47CC_005MH

Insp Date: **7/21/08 10:18 AM**

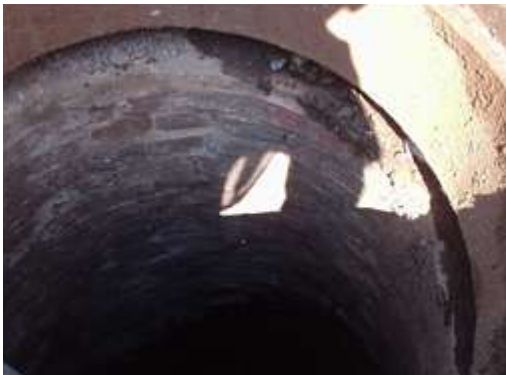
Defect 4

☒ **Leaks**

Frame Leaks

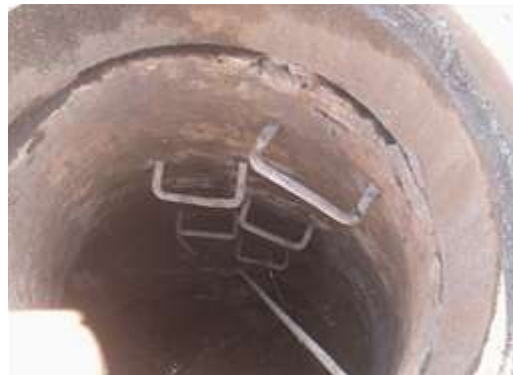
Defect 3

☒ **Mortar**

Infiltration

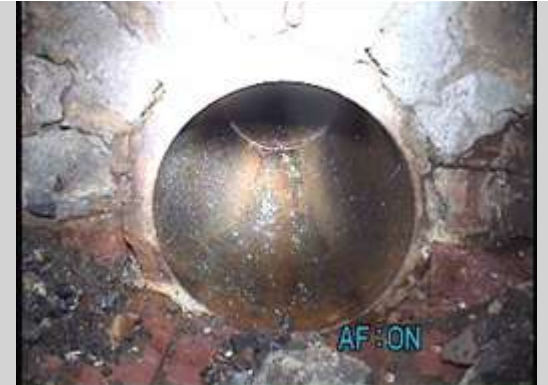
12 O'Clock Outflow

8 in. Circular Gravity Sewer
Pipe Out @ 12 O'Clock

Infiltration: **None** Pipe Seal Cond: **Sound**

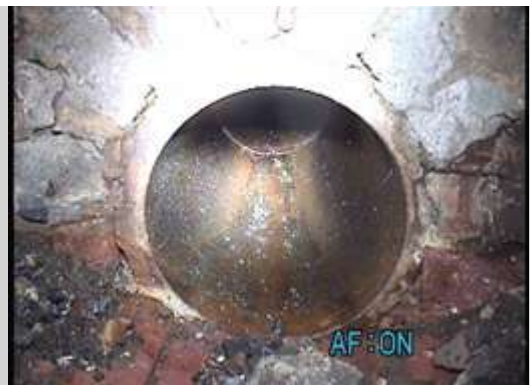
12 O'Clock Outflow

8 in. Circular Gravity Sewer
Pipe Out @ 12 O'Clock

Infiltration: **None** Pipe Seal Cond: **Sound**
